# Open stone asphalt revetment Expert Review

Client: Private Developer

Services provided:

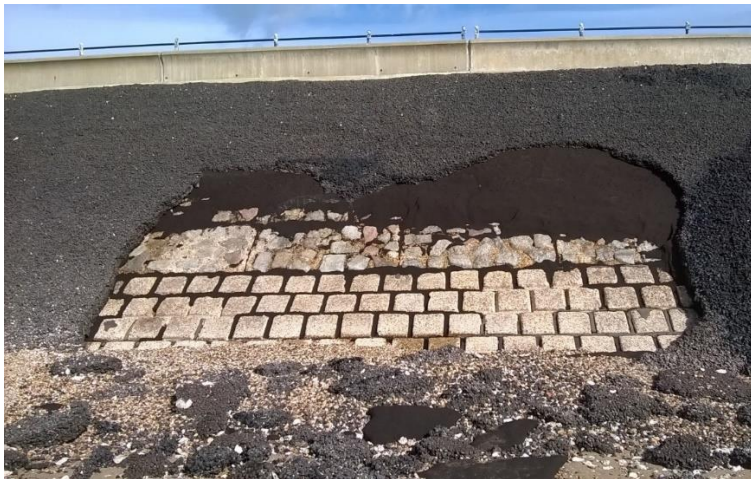
Loss of the open stone revetment revealing the Essex blocks beneath, April 2016
