# Aldeburgh Coastal Defences

## Design of sea defence improvements

Aldeburgh, Suffolk, UK

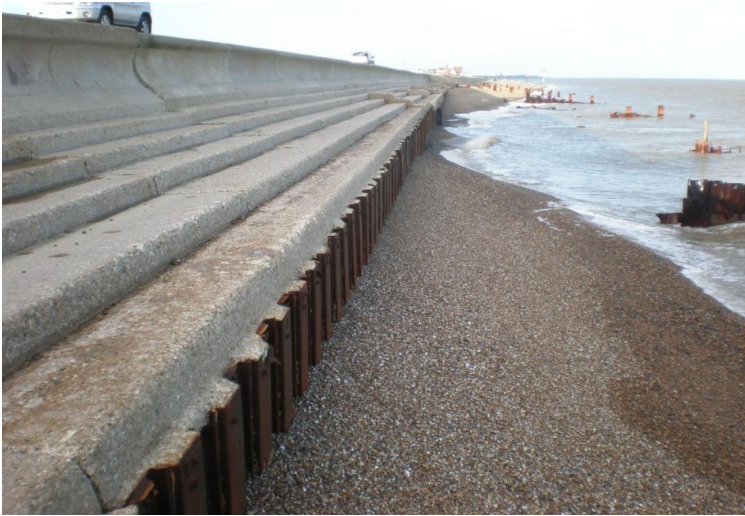
Exposed sheet pile toe at Slaughden, south of Aldeburgh – February 2015

Rapid beach loss had been experienced during the winter of 2013/14 at Slaughden just south of Aldeburgh. A breach of the seawall at this location would provide a new connection to the estuary behind, adversely affecting people, property, businesses and the environment. The Environment Agency had funds available to reinstate the coastal defences over a 200m length in order to protect against failure of the seawall, and sought assistance from ENBE to develop a concept and to assist the Client with detailed design.
